**Flood Control Project Maintenance
Levee Inspections**

2013 Channel Summary Report

Madera County FCWCA

Flood Control Project Maintenance**Unit Cover Sheet****2013 Channel Inspection Results****Madera County FCWCA**

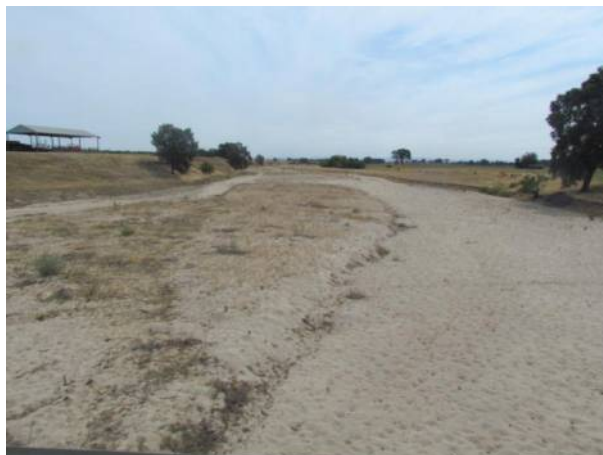
richard_c_20130827_065.JPG

Looking east (upstream) at channel from Santa Fe Drive.

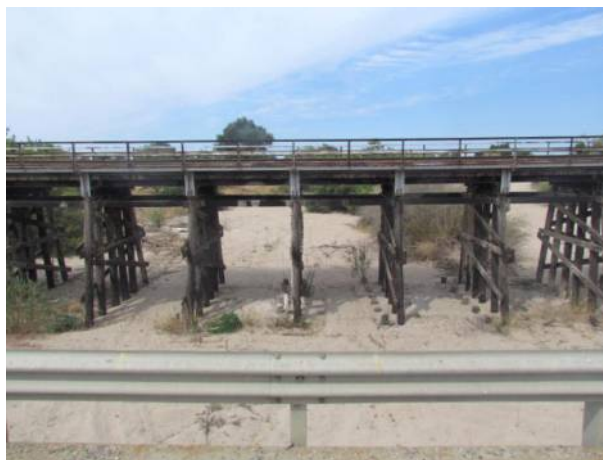
Levee Mile Report Line	16
Start Levee Mile	0.00
End Levee Mile	0.00
Location	
Category	Channels
Item	Vegetation & Obstructions

Looking west (downstream) at channel from Santa Fe Drive.

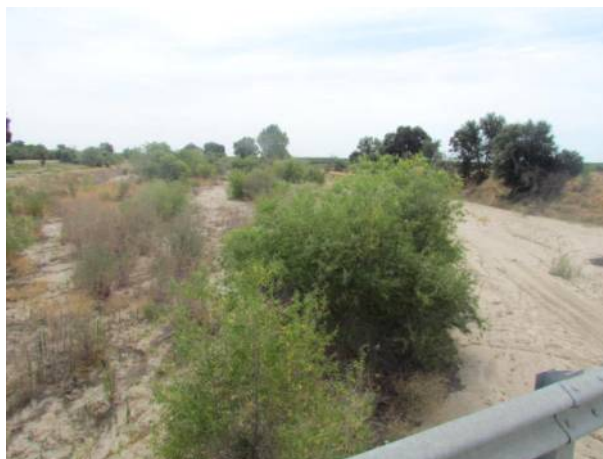
Levee Mile Report Line	21
Start Levee Mile	0.00
End Levee Mile	0.00
Location	
Category	Channels
Item	Vegetation & Obstructions

Looking east (upstream) at channel from White Rock Road.

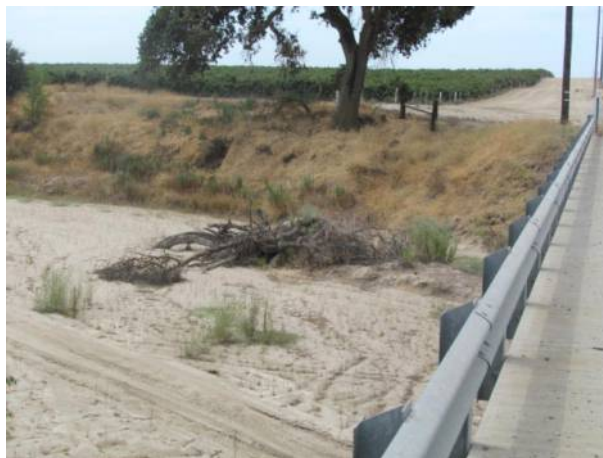
Levee Mile Report Line	25
Start Levee Mile	0.00
End Levee Mile	0.00
Location	
Category	Channels
Item	Encroachments

Looking southeast at brush pile in channel from Road 19.

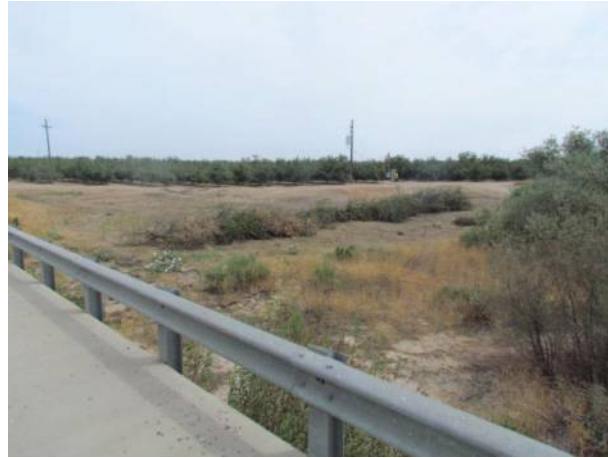
Levee Mile Report Line	25
Start Levee Mile	0.00
End Levee Mile	0.00
Location	
Category	Channels
Item	Encroachments

Looking northeast at brush pile in channel from Road 19.

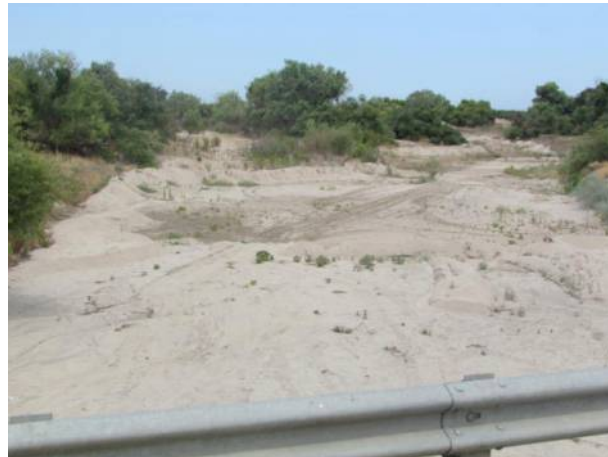
Levee Mile Report Line	26
Start Levee Mile	0.00
End Levee Mile	0.00
Location	
Category	Channels
Item	Vegetation & Obstructions

Looking west (downstream) at channel from Road 19.

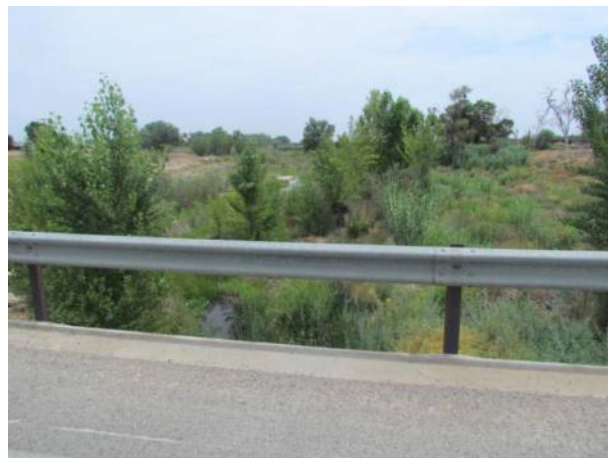
Levee Mile Report Line	30
Start Levee Mile	0.00
End Levee Mile	0.00
Location	
Category	Channels
Item	Vegetation & Obstructions

Looking east (upstream) at channel from Road 13.

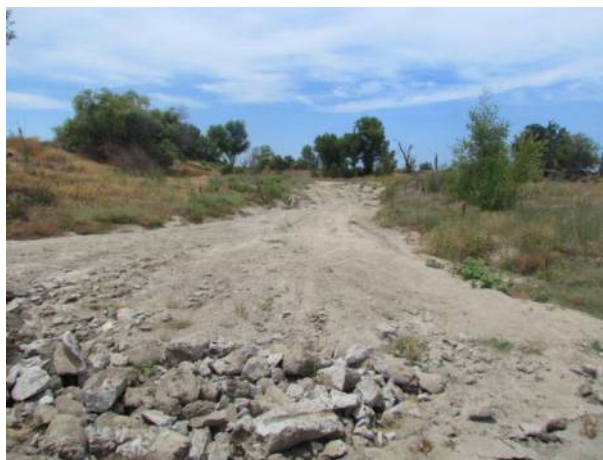
Levee Mile Report Line	45
Start Levee Mile	0.00
End Levee Mile	0.00
Location	
Category	Channels
Item	Vegetation & Obstructions

Looking west (downstream) at channel from Road 12.

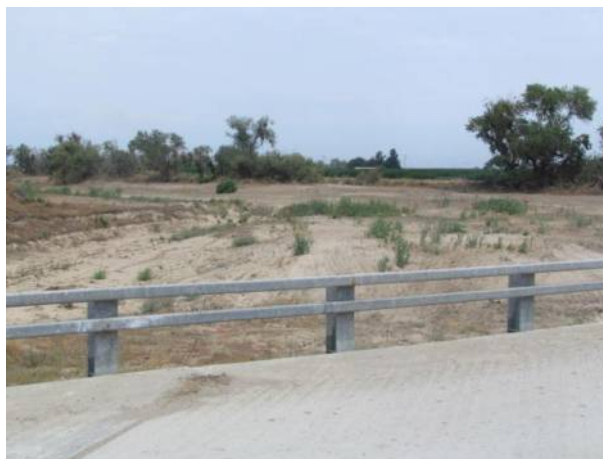
Levee Mile Report Line	50
Start Levee Mile	0.00
End Levee Mile	0.00
Location	
Category	Channels
Item	Vegetation & Obstructions

Looking east (upstream) at channel form Avenue 23 1/2.

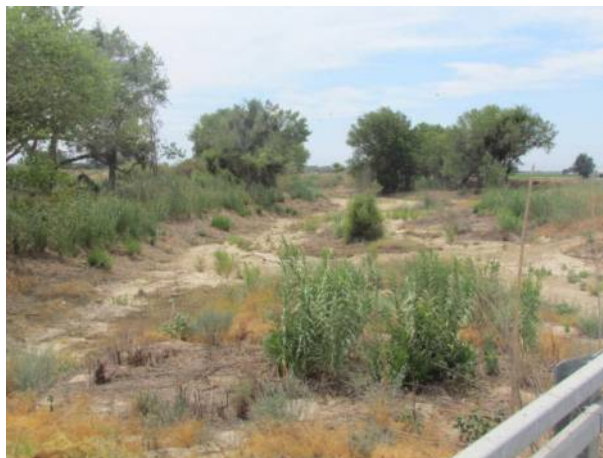
Levee Mile Report Line	55
Start Levee Mile	0.00
End Levee Mile	0.00
Location	
Category	Channels
Item	Vegetation & Obstructions

Looking west (downstream) at channel from Avenue 23 1/2

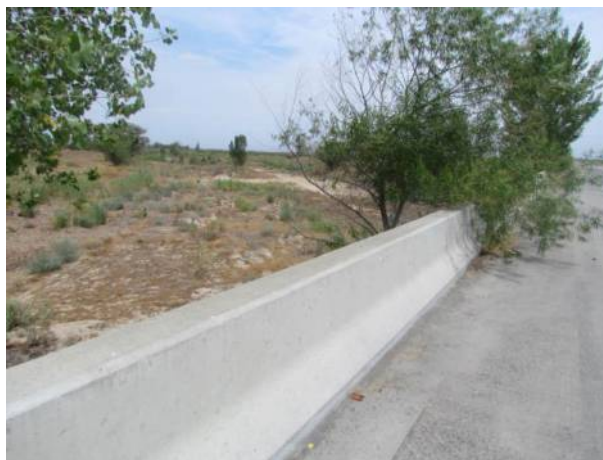
Levee Mile Report Line	60
Start Levee Mile	0.00
End Levee Mile	0.00
Location	
Category	Channels
Item	Vegetation & Obstructions

Looking east (upstream) at channel from Hwy 152.

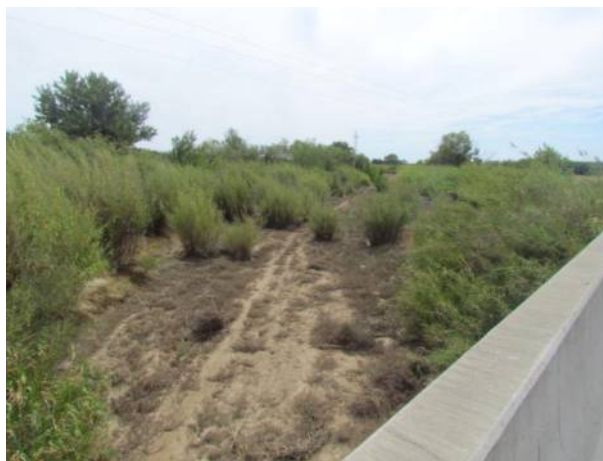
Levee Mile Report Line	65
Start Levee Mile	0.00
End Levee Mile	0.00
Location	
Category	Channels
Item	Vegetation & Obstructions

Looking west (downstream) at channel from Hwy. 152.

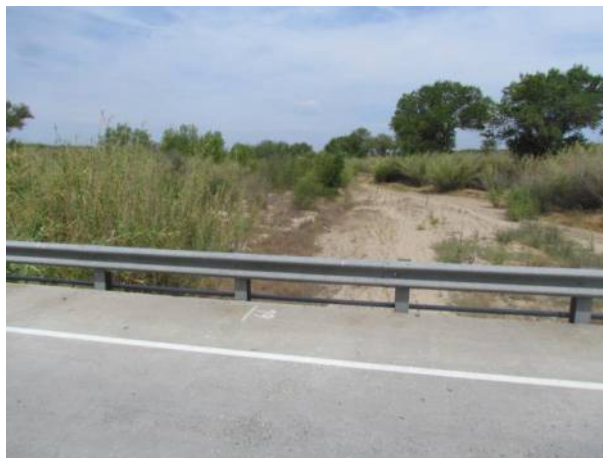
Levee Mile Report Line	70
Start Levee Mile	0.00
End Levee Mile	0.00
Location	
Category	Channels
Item	Vegetation & Obstructions

Looking east (upstream) at channel from Road 9.

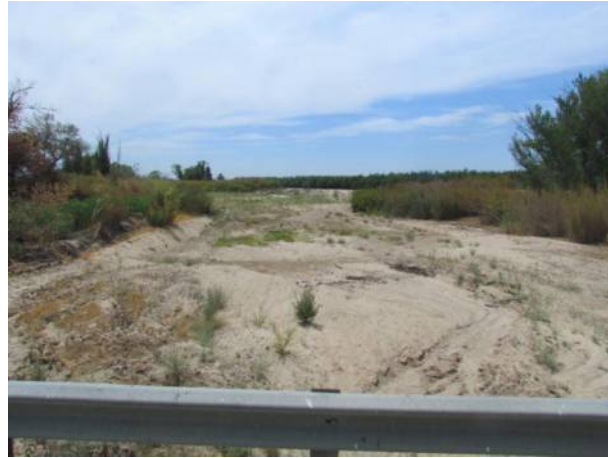
Levee Mile Report Line	75
Start Levee Mile	0.00
End Levee Mile	0.00
Location	
Category	Channels
Item	Vegetation & Obstructions

Looking west (downstream) at channel from Road 9.

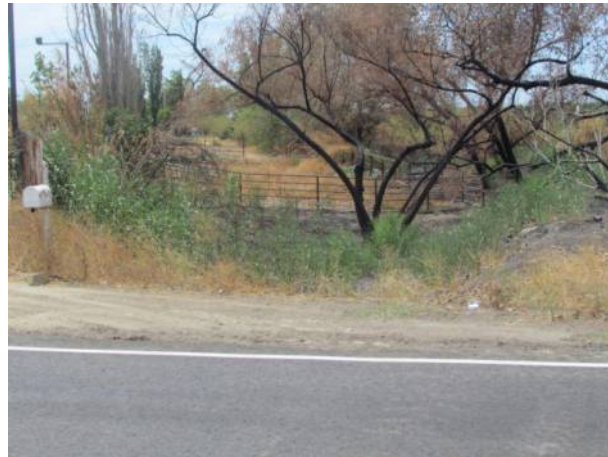
Levee Mile Report Line	79
Start Levee Mile	0.00
End Levee Mile	0.00
Location	
Category	Channels
Item	Encroachments

Looking west at animal pen in channel from Road 9.

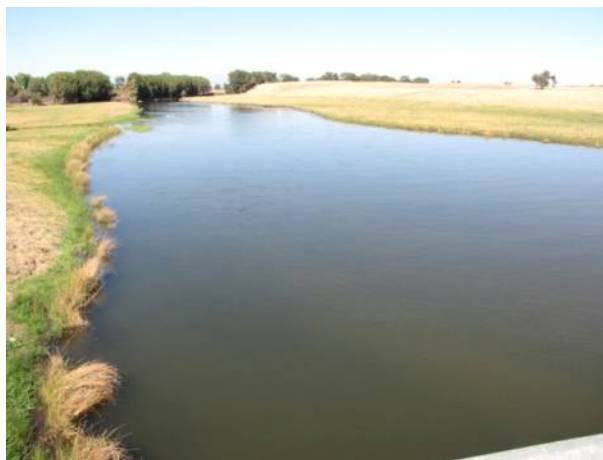
phillips_c_20130830_164.JPG

Berenda Slough looking upstream from Santa Fe Dr. crossing the channel. Photo taken 7-31-2013.

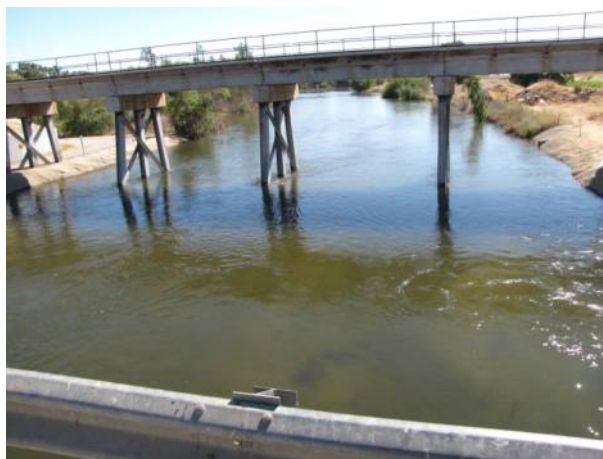
Levee Mile Report Line	6
Start Levee Mile	0.00
End Levee Mile	0.00
Location	
Category	Channels
Item	Vegetation & Obstructions

Berenda Slough looking downstream from Santa Fe Dr. Photo taken 7-31-2013.

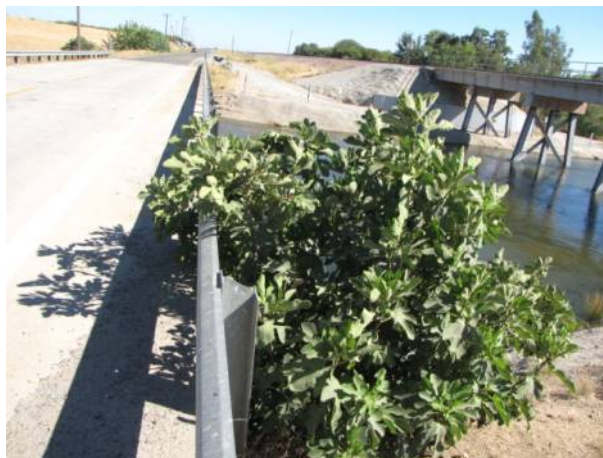
Levee Mile Report Line	10
Start Levee Mile	0.00
End Levee Mile	0.00
Location	
Category	Channels
Item	Encroachments

Property owner has planted a fig tree at right bank bridge abutment downstream. Photo taken 7-31-2013.

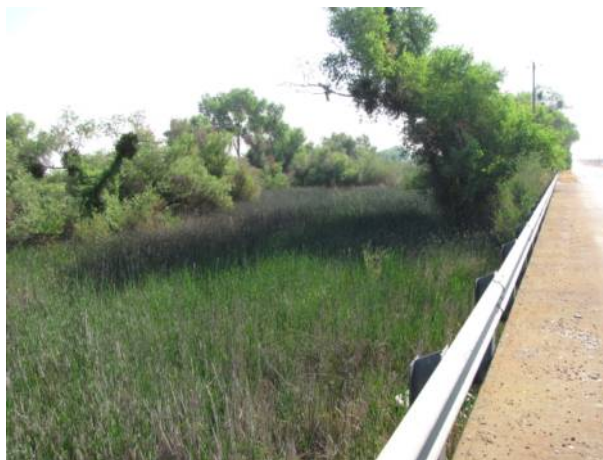
phillips_c_20130830_167.JPG

Berenda Slough looking upstream from 26 Ave. Channel covered with tulies. Photo taken 7-31-2013.

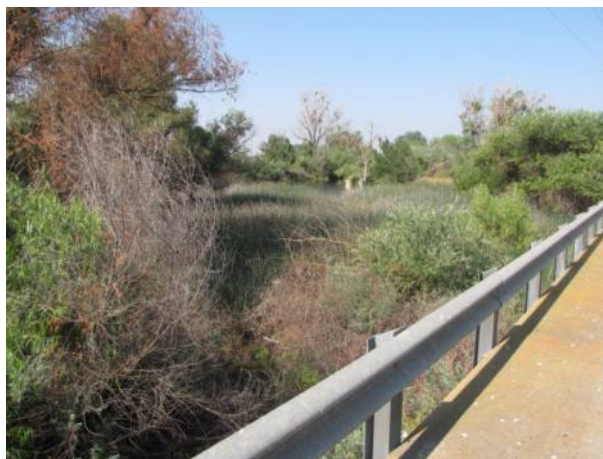
Levee Mile Report Line	16
Start Levee Mile	0.00
End Levee Mile	0.00
Location	
Category	Channels
Item	Vegetation & Obstructions

Berenda Slough looking downstream from Ave. 26 channel choked with wild growth. Photo taken 7-31-2013.

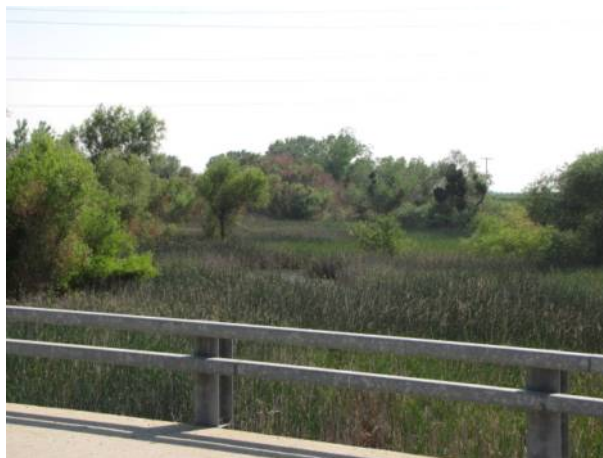
Levee Mile Report Line	21
Start Levee Mile	0.00
End Levee Mile	0.00
Location	
Category	Channels
Item	Vegetation & Obstructions

Berenda Slough looking upstream from Rd 19 channel choked with tulie. Photo taken 7-31-2013.

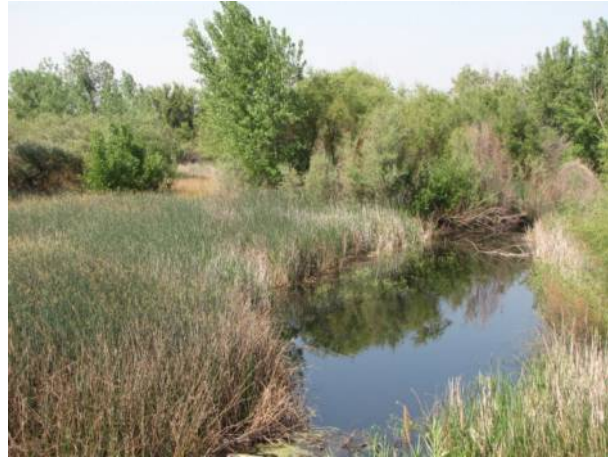
phillips_c_20130830_170.JPG

Berenda Slough looking downstream from Rd 19 wild growth in channel. Photo taken 7-31-2013.

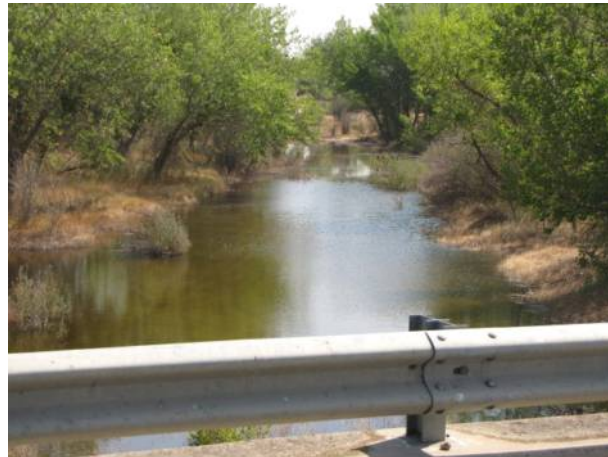
Levee Mile Report Line	31
Start Levee Mile	0.00
End Levee Mile	0.00
Location	
Category	Channels
Item	Vegetation & Obstructions

Berenda Slough looking upstream from the Chowchilla Blvd crossing. Photo taken 7-31-2013.

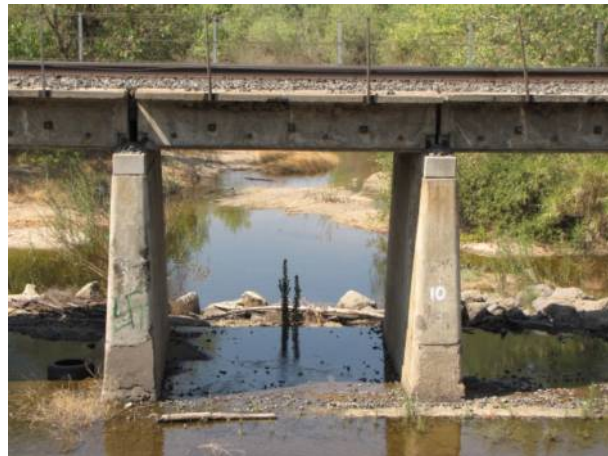
Levee Mile Report Line	36
Start Levee Mile	0.00
End Levee Mile	0.00
Location	
Category	Channels
Item	Vegetation & Obstructions

Berenda Slough looking downstream from Chowchilla Blvd. Photo taken 7-31-2013.

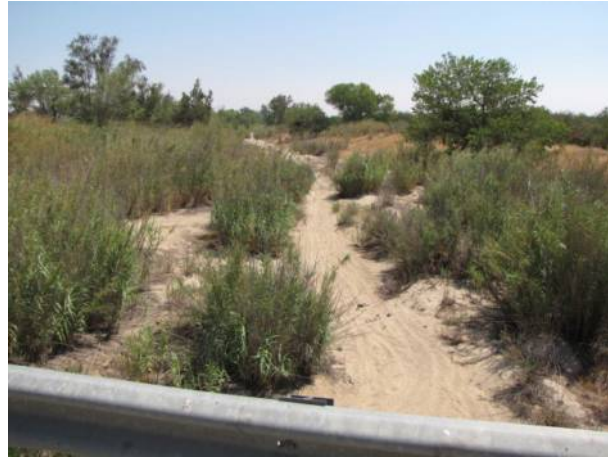
phillips_c_20130830_173.JPG

Berenda Slough looking upstream from Rd 16. Growth in channel. Photo taken 7-31-2013.

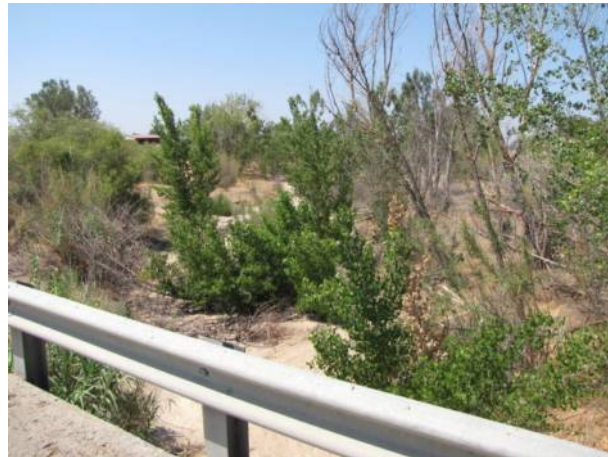
Levee Mile Report Line	46
Start Levee Mile	0.00
End Levee Mile	0.00
Location	
Category	Channels
Item	Vegetation & Obstructions

Berenda Slough downstream from Rd. 16. Photo taken 7-31-2013.

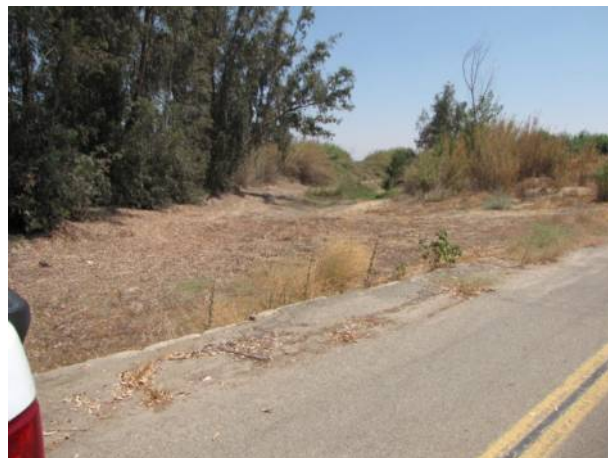
Levee Mile Report Line	51
Start Levee Mile	0.00
End Levee Mile	0.00
Location	
Category	Channels
Item	Vegetation & Obstructions

Berenda Slough from Ave. 22. Photo taken 7-31-2013.

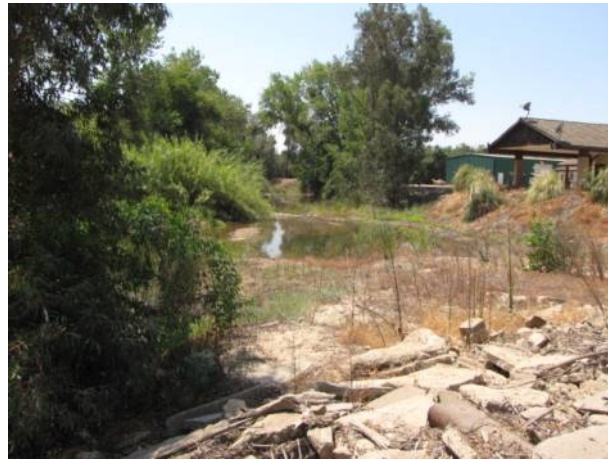
phillips_c_20130830_176.JPG

Berenda Slough at Ave. 22 crossing. Photo taken 7-31-2013.

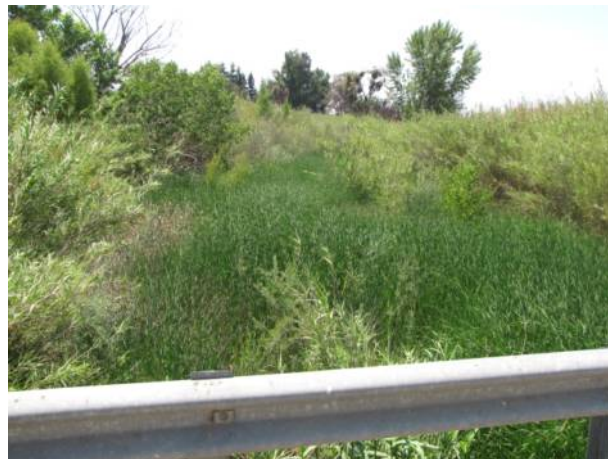
Levee Mile Report Line	61
Start Levee Mile	
End Levee Mile	
Location	
Category	Channels
Item	Vegetation & Obstructions

Berenda Slough looking upstream from Ave.21. Channel and both banks overgrown with wild growth. Photo taken 7-31-2013.

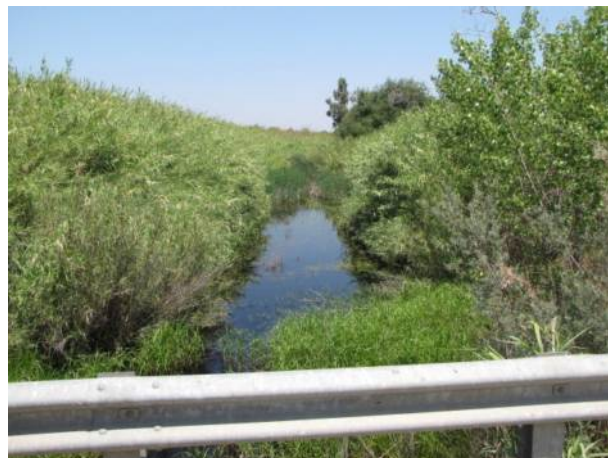
Levee Mile Report Line	65
Start Levee Mile	
End Levee Mile	
Location	
Category	Channels
Item	Vegetation & Obstructions

Berenda Slough looking downstream from Ave 21. Photo taken 7-31-2013.

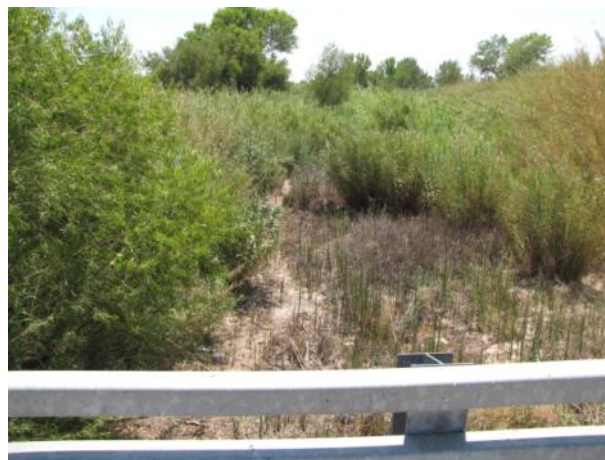
phillips_c_20130830_178.JPG

Looking upstream from Ave 20 channel overgrown. Photo taken 7-31-2013.

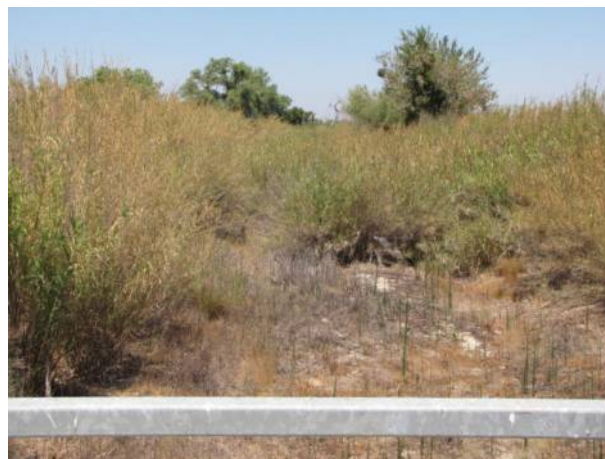
Levee Mile Report Line	76
Start Levee Mile	0.00
End Levee Mile	0.00
Location	
Category	Channels
Item	Vegetation & Obstructions

Berenda Slough looking downstream from Ave.20. Bambo has covered channel and both banks. Photo taken 7-31-2013.

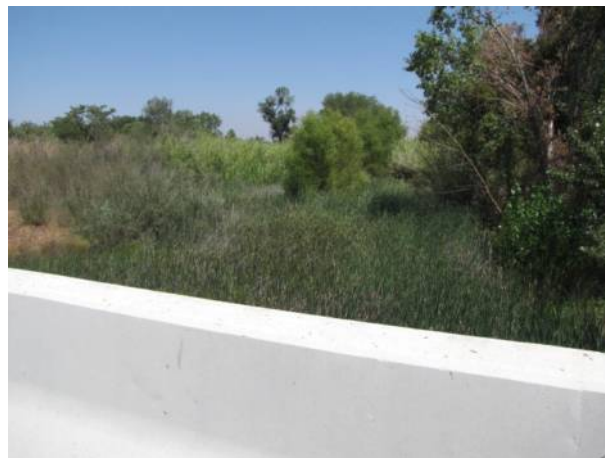
Levee Mile Report Line	81
Start Levee Mile	0.00
End Levee Mile	0.00
Location	
Category	Channels
Item	Vegetation & Obstructions

Berenda Slough at Rd 13 crossing. Channel overgrown. Photo taken 7-31-2013.

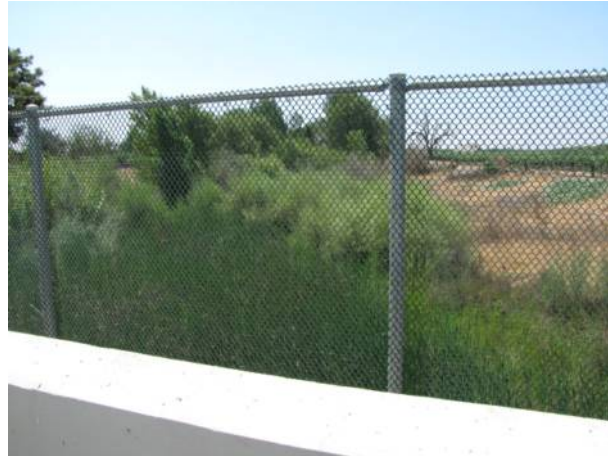
phillips_c_20130830_182.JPG

Berenda slough from Rd 13. Overgrown channel. Photo taken 7-31-2013.

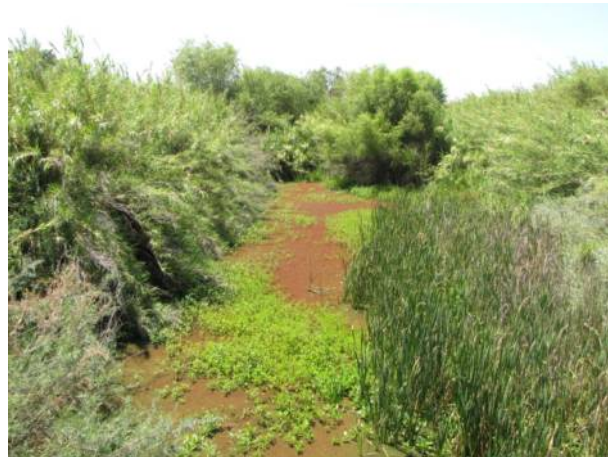
Levee Mile Report Line	91
Start Levee Mile	0.00
End Levee Mile	0.00
Location	
Category	Channels
Item	Vegetation & Obstructions

Berenda Slough looking upstream from Rd. 14 channel and banks overgrown. Photo taken 7-31-2013.

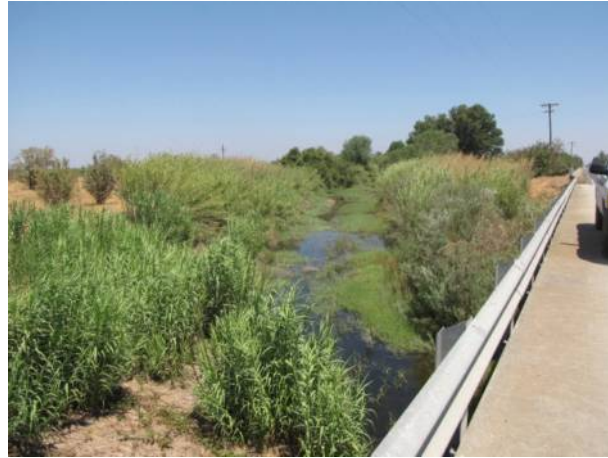
phillips_c_20130830_185.JPG

Berenda Slough looking upstream from Ave 18 1/2 some wild growth in channel both banks overgrown. Photo taken 7-31-2013.

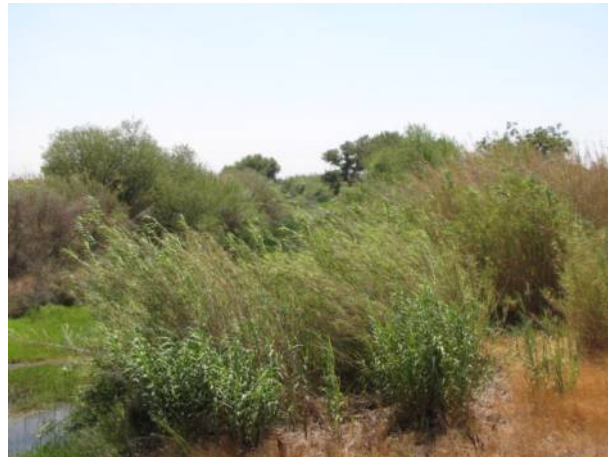
Levee Mile Report Line	105
Start Levee Mile	0.00
End Levee Mile	0.00
Location	
Category	Channels
Item	Vegetation & Obstructions

Berenda Slough looking downstream from Ave 18 1/2. Wild growth in channel and on both banks. Photo taken 7-31-2013.

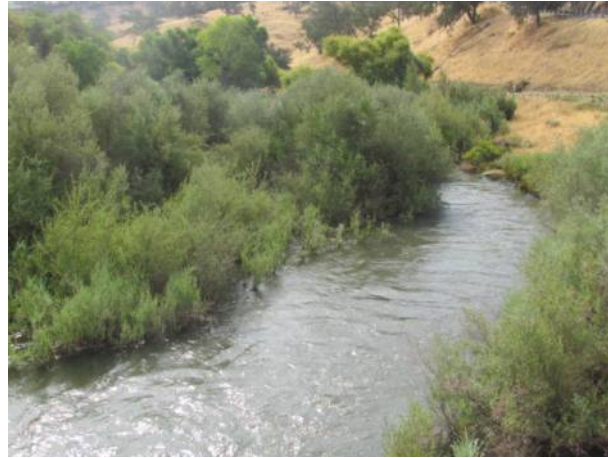
richard_c_20130827_040.JPG

Looking upstream from County Road 29.

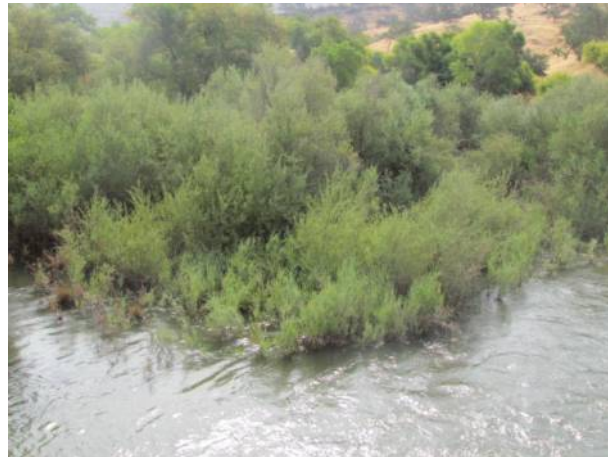
Levee Mile Report Line	1
Start Levee Mile	0.00
End Levee Mile	0.00
Location	
Category	Channels
Item	Vegetation & Obstructions

Looking upstream at willows in the middle of the channel from County Road 29.

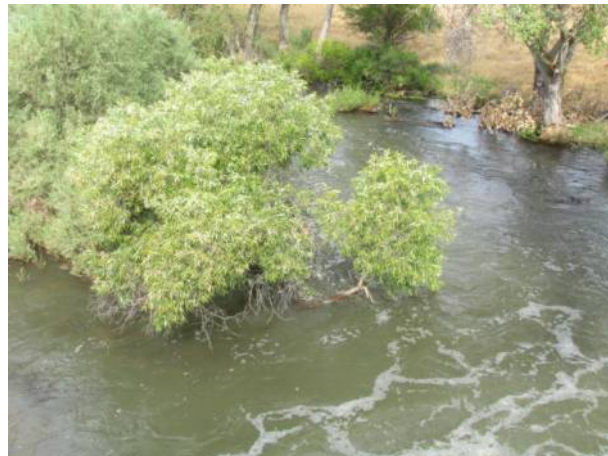
Levee Mile Report Line	6
Start Levee Mile	
End Levee Mile	
Location	
Category	Channels
Item	Vegetation & Obstructions

Looking downstream from County Road 29.

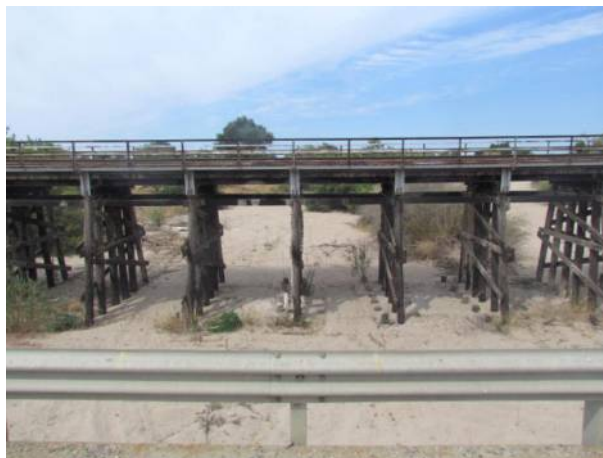
Levee Mile Report Line	16
Start Levee Mile	
End Levee Mile	
Location	
Category	Channels
Item	Vegetation & Obstructions
Looking downstream at channel from Santa Fe Drive.	
richard_c_20130827_045.JPG

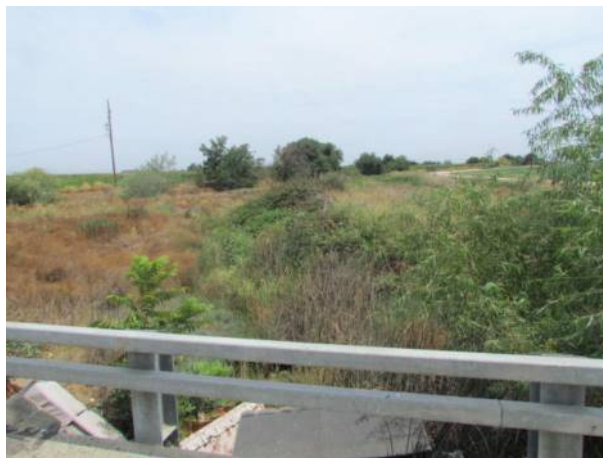
Levee Mile Report Line	31
Start Levee Mile	
End Levee Mile	
Location	
Category	Channels
Item	Vegetation & Obstructions
Looking east (upstream) at channel from Road 13.	
richard_c_20130827_050.JPG

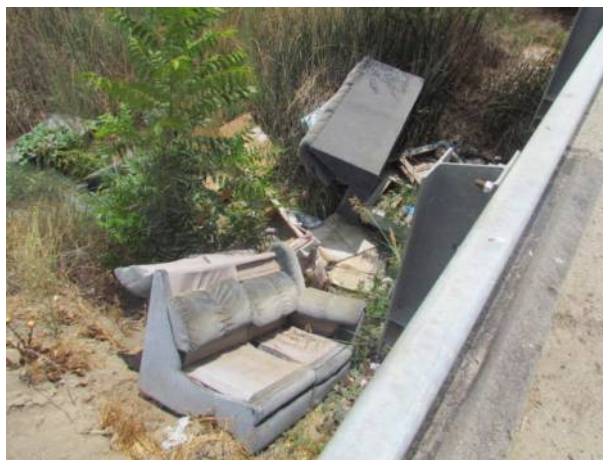
richard_c_20130827_051.JPG

Levee Mile Report Line	35
Start Levee Mile	
End Levee Mile	
Location	
Category	Channels
Item	Encroachments

Looking southeast at trash in channel.

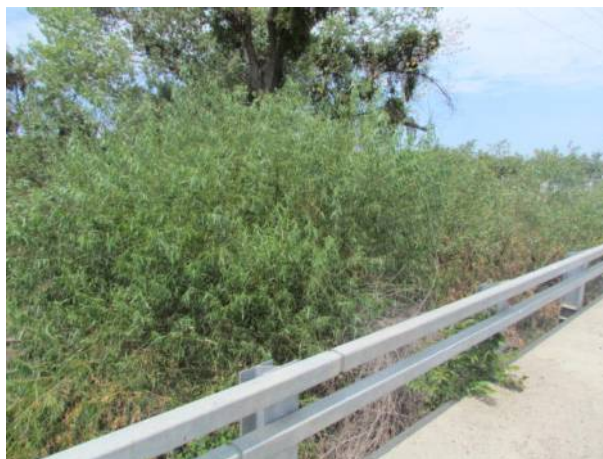
richard_c_20130827_052.JPG

Levee Mile Report Line	36
Start Levee Mile	
End Levee Mile	
Location	
Category	Channels
Item	Vegetation & Obstructions

Looking west (downstream) from Road 13.

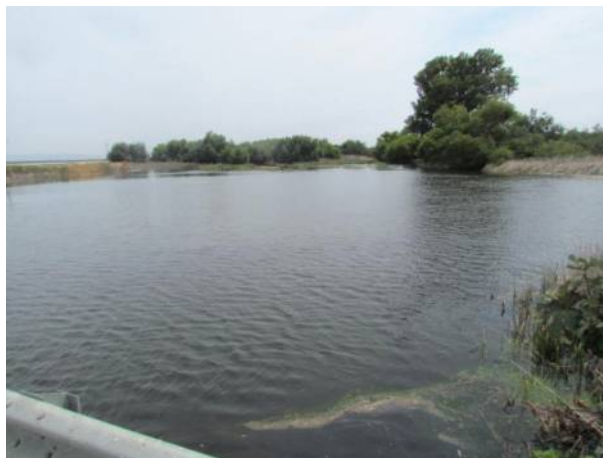
richard_c_20130827_048.JPG

Levee Mile Report Line	41
Start Levee Mile	
End Levee Mile	
Location	
Category	Channels
Item	Vegetation & Obstructions

Looking east (upstream) at channel from Road 15.

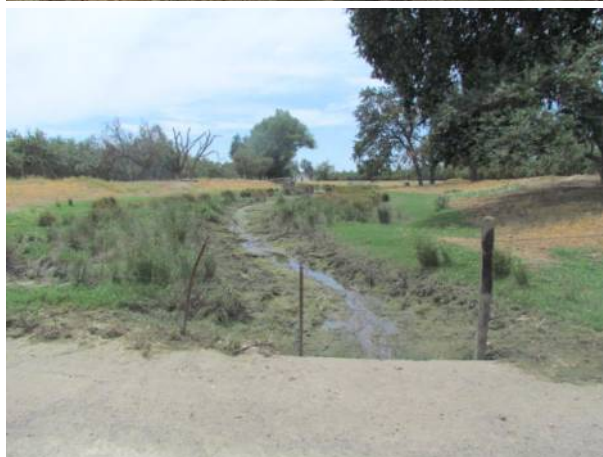
Levee Mile Report Line	56
Start Levee Mile	
End Levee Mile	
Location	
Category	Channels
Item	Vegetation & Obstructions
Looking west (downstream) at channel from Road 11.	
richard_c_20130827_054.JPG

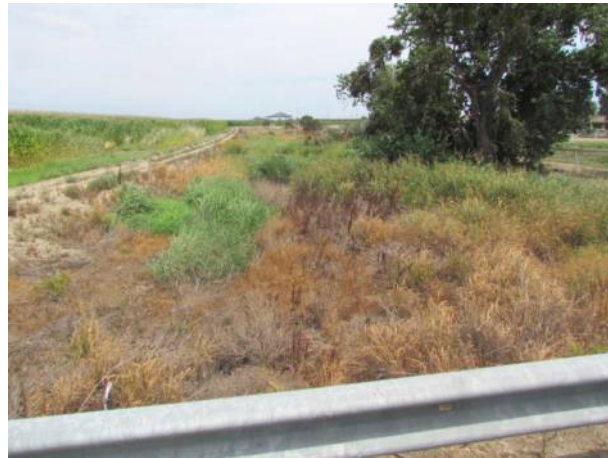
richard_c_20130827_055.JPG

Looking east (upstream) at channel from Road 9.

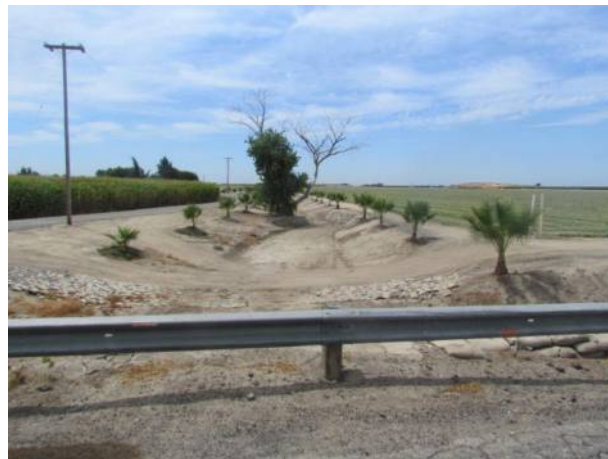
richard_c_20130827_056.JPG

Levee Mile Report Line	70
Start Levee Mile	
End Levee Mile	
Location	
Category	Channels
Item	Encroachments

Looking west (downstream) at palm trees in channel from Road 9.

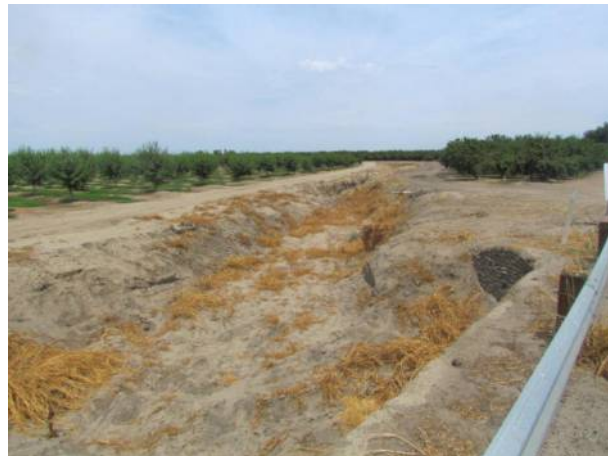
richard_c_20130827_057.JPG

Looking east (upstream) at channel from Avenue 25 & Washington Road.

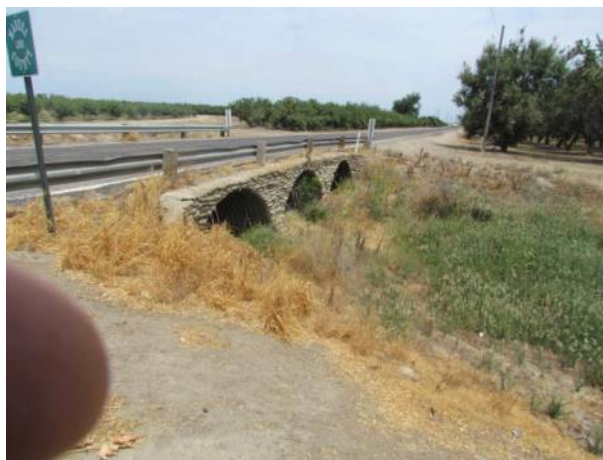
richard_c_20130827_060.JPG

Looking southeast at culverts on west side of Avenue 25 & Washington Road.

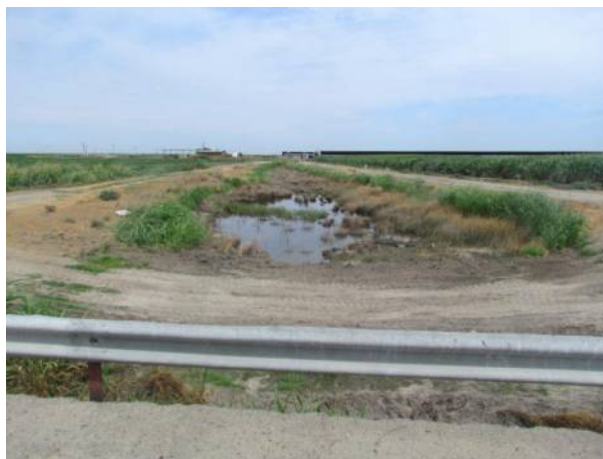
richard_c_20130827_061.JPG

Looking east (upstream) at channel from Shultz Road & Road 5 1/2.

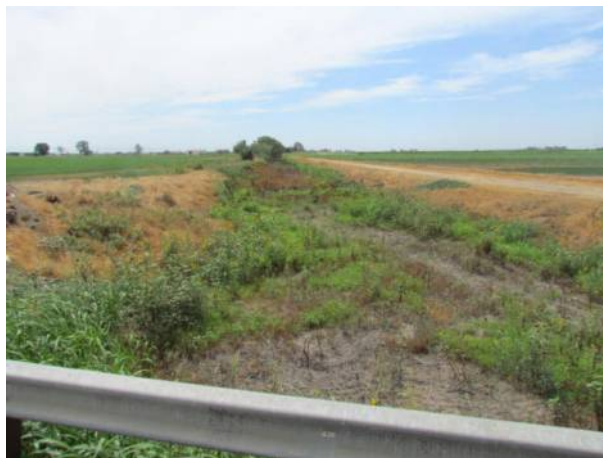
richard_c_20130827_062.JPG

Looking west (downstream) at channel from Shultz Rd & Road 5 1/2.

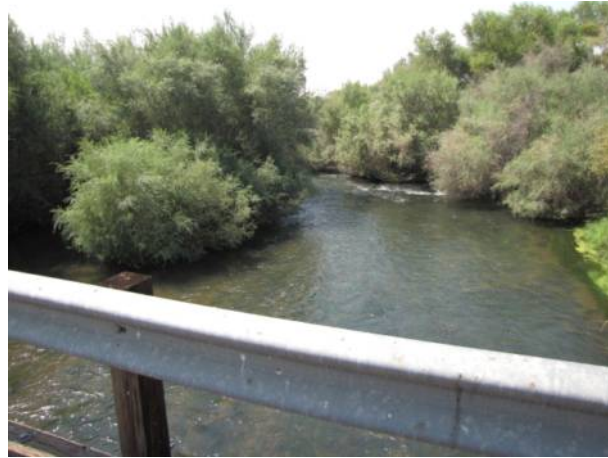
phillips_c_20130830_151.JPG

Looking downstream from the bridge. Photo taken 7-30-2013.

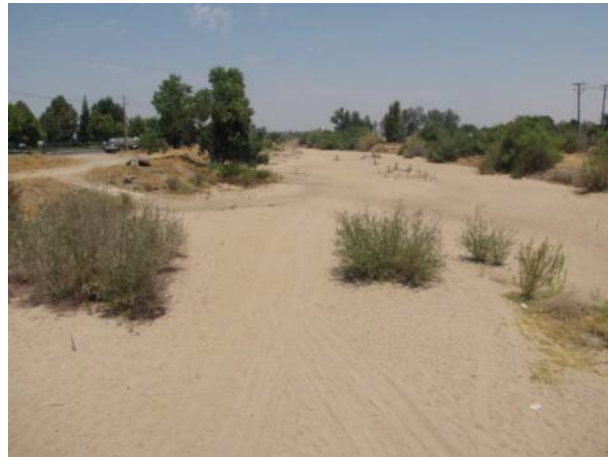
phillips_c_20130830_152.JPG

Fresno River looking upstream from Cleveland Ave crossing. Photo taken 7-30-2013.

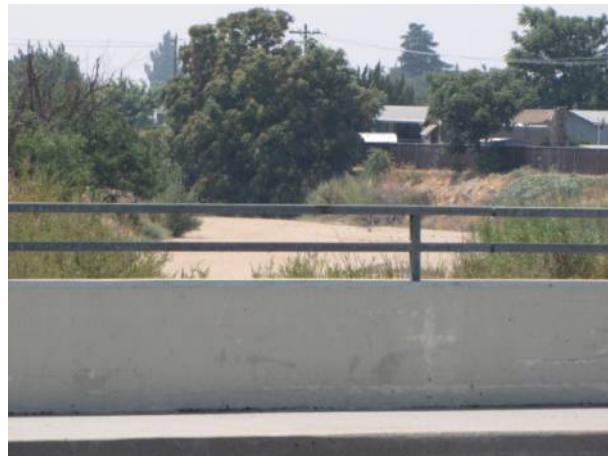
phillips_c_20130830_153.JPG

Fresno River from Cleveland Avenue bridge crossing looking downstream. Photo taken 7-30-2013.

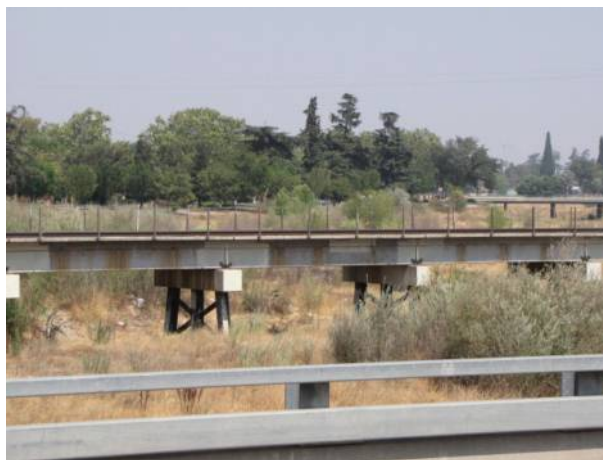
phillips_c_20130830_154.JPG

Fresno River from Gtewaw crossing looking upstream of channel. Photo taken 7-30-2013.

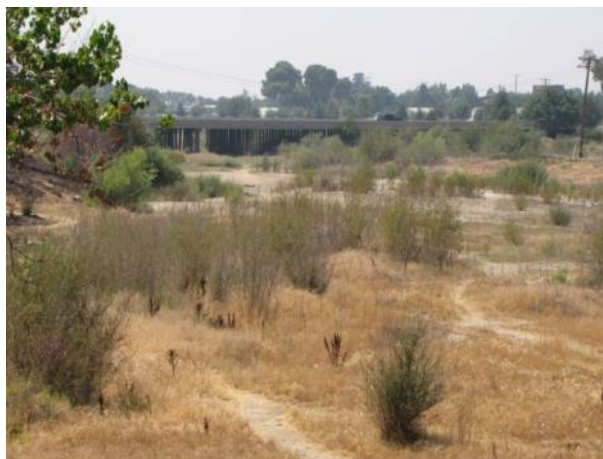
phillips_c_20130830_155.JPG

Fresno River from Gateway Bridge crossing looking downstream. Photo taken 7-30-2013.

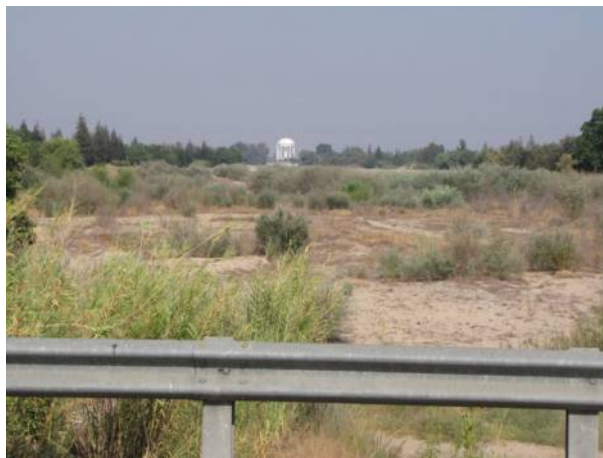
phillips_c_20130830_156.JPG

Fresno River from Granada Ave crossing looking upstream from bridge. There is growth in channel. Photo taken 7-30-2013.

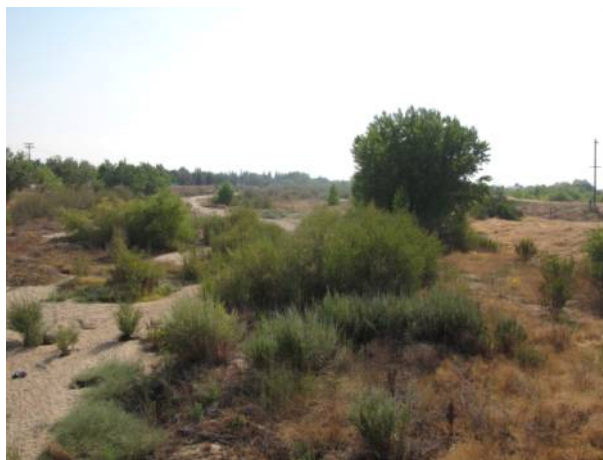
phillips_c_20130830_157.JPG

Fresno River looking downstream from Granada Ave. Note the young tree growth in channel.
Photo taken 7-30-2013.

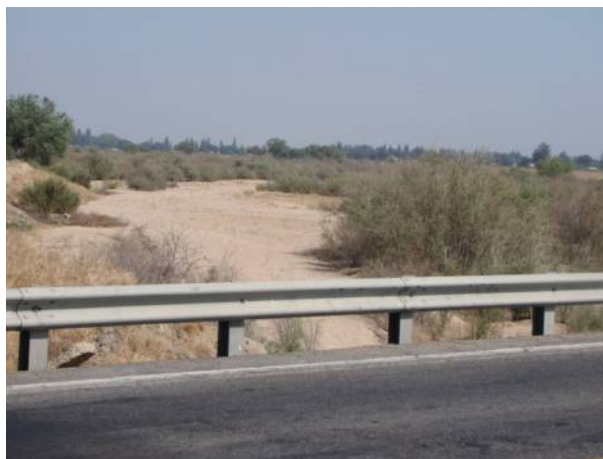
phillips_c_20130830_158.JPG

Fresno River crossing looking upstream from Road 23, note the young willows in channel.
Photo taken 7-30-2013.

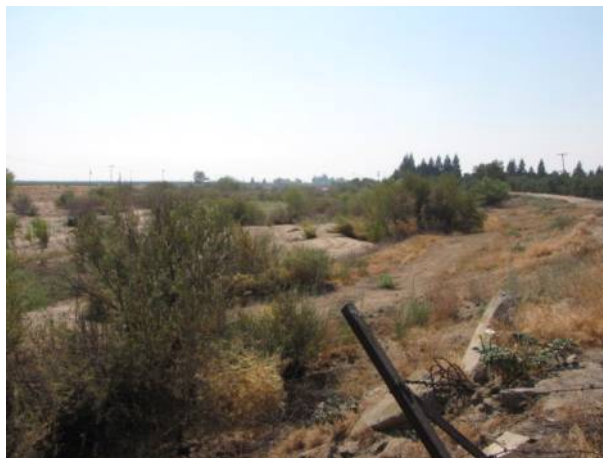
phillips_c_20130830_159.JPG

Fresno River looking downstream from bridge crossing. Some growth present in channel.
Photo taken 7-30-2013.

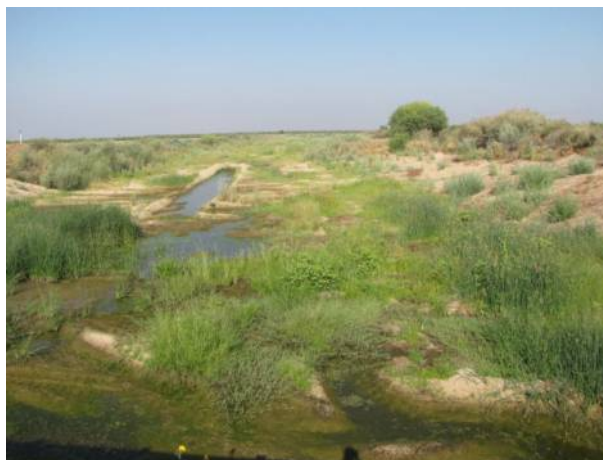
phillips_c_20130830_160.JPG

Fresno River looking upstream from Road 20 crossing. Photo taken 7-30-2013.

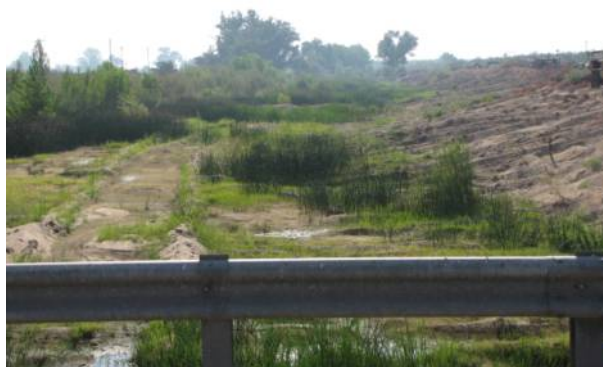
phillips_c_20130830_161.JPG

Fresno River looking downstream from Road crossing work has been done in channel right bank. Photo taken 7-30-2013.

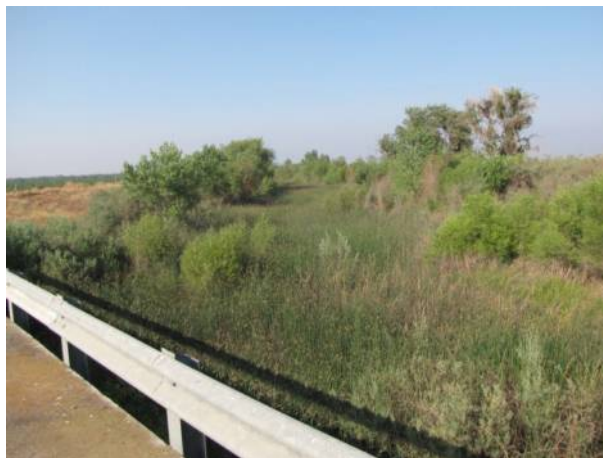
phillips_c_20130830_162.JPG

Fresno River looking upstream from Rd.19, D/S. Note the tulies and other growth in channel. Photo taken 7-30-2013.

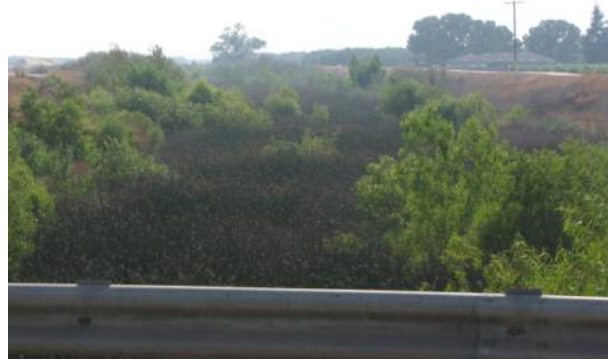
phillips_c_20130830_163.JPG

Fresno River looking downstream from bridge crossing. The channel is choked with wild growth. Photo taken 7-30-2013.
